Flood Control Project Maintenance
Levee Inspections

Fall 2013 Levee Maintenance Deficiency Summary Report

Sacramento River Basin

| RD0999 Reclamation District No. 0999 Netherlands | Overall LMA Rating | Total LMA Miles | | | | | | | |

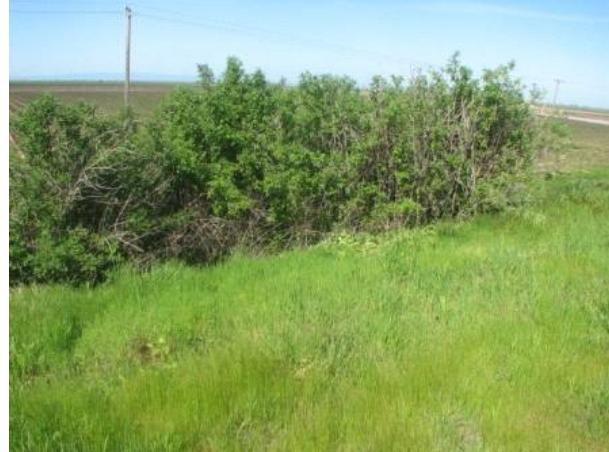
| Elderberries blocking view of landside toe. | |

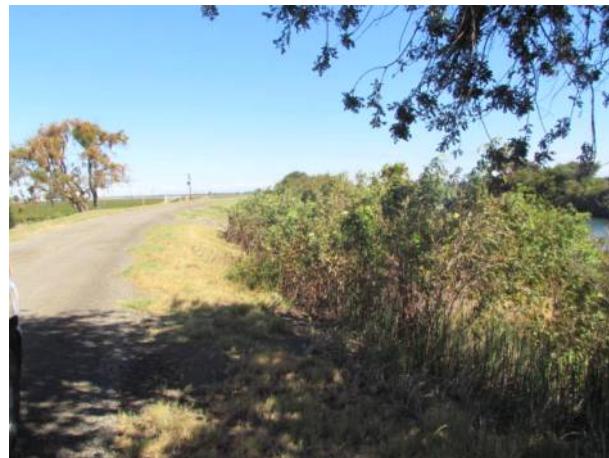
| Looking northeast at dense elderberry on waterward slope. | |

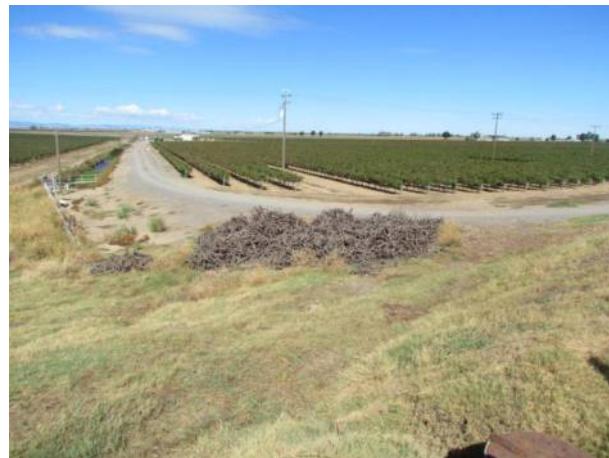
| Looking west at prunings on landward berm. | |

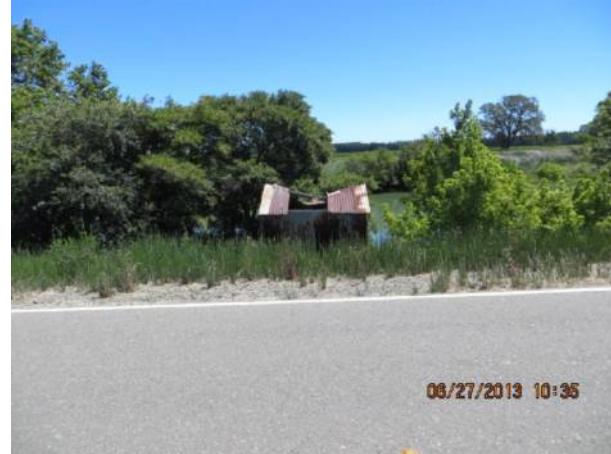
| Pumphouse visible on WS slope. | |

| Waterway | | | | | | | | Bank | Unit Miles | Inspection Start/End | Inspector |
|---|---|---|---|---|---|---|---|---|---|---|---|
| 16 | 0.71 | 0.71 | Supplemental DWR UCIP Field Study | LS En | M | EP_NO: 3973 | Inspector Comments: FS_ID:15711 Repair Type: Non-Urgent Crossing Status: Found UCIP Comments: Slide gate broken on LS toe. Appears it may be abandoned. FIELD_STRUCT_DESC: 18-inch steel stormdrain pipe through the levee 4.7 feet below the crown. air vent in 18-inch steel standpipe on the waterward shoulder. Gate valve on the land side toe (Permit No. 3973, 1962). Originally included in the 1966 O&M manual. FS Date: 07/12/2013 | 38.423054 ° | 38.423054 ° | 25 | |

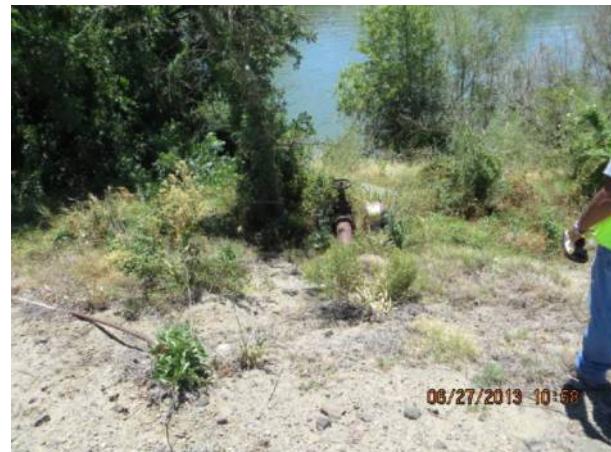
| Pipe visible on WS slope. | |

| Waterway | | | | | | | | Bank | Unit Miles | Inspection Start/End | Inspector |
|---|---|---|---|---|---|---|---|---|---|---|---|
| 18 | 0.71 | 0.71 | Supplemental DWR UCIP Field Study | LS En | M | EP_NO: 3973 | Inspector Comments: FS_ID:15712 Repair Type: Non-Urgent Crossing Status: Found UCIP Comments: Slide gate broken on LS toe. Appears it may be abandoned. FIELD_STRUCT_DESC: 18-inch steel stormdrain pipe through the levee 4.7 feet below the crown. air vent in 18-inch steel standpipe on the waterward shoulder. Gate valve on the land side toe (Permit No. 3973, 1962). Originally included in the 1966 O&M manual. FS Date: 07/12/2013 | 38.423062 ° | 38.423062 ° | 26 | |

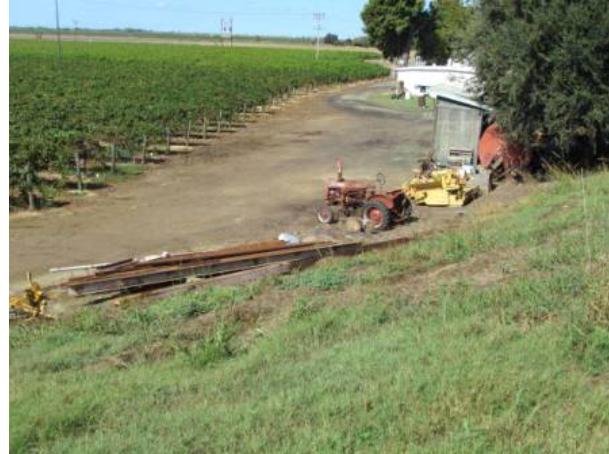
| Looking northwest at equipment at landside toe. | |

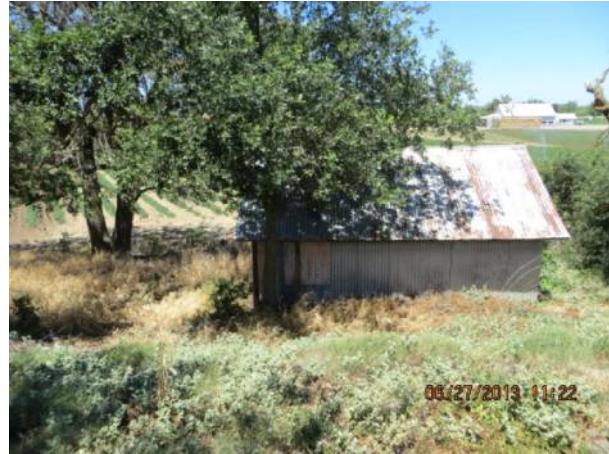
Pumphouse on LS toe.

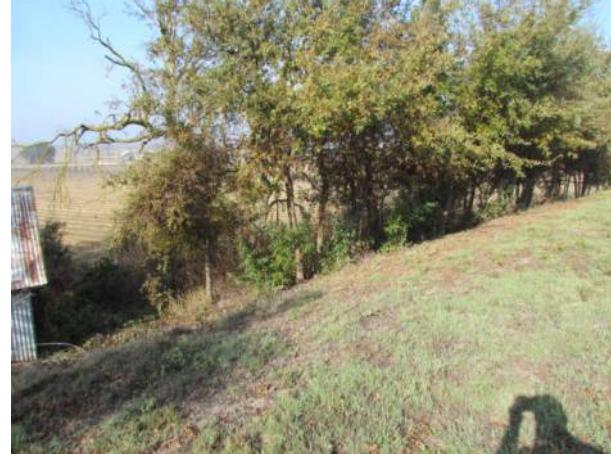
| Looking northwest at dense vegetation at landside slope and toe. | |

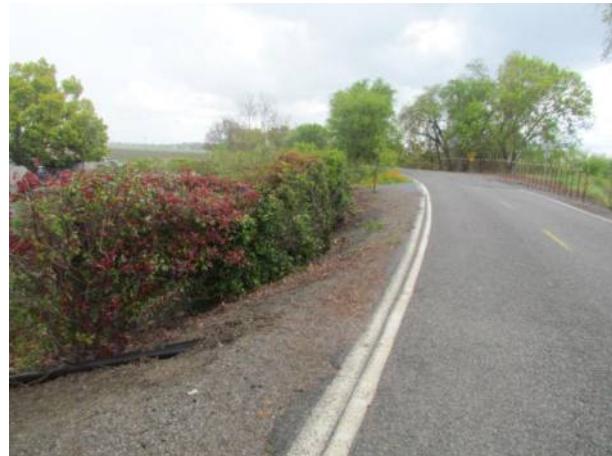
| Looking southwest at trimmed landscaping on landside slope, but still blocking levee slope. | |

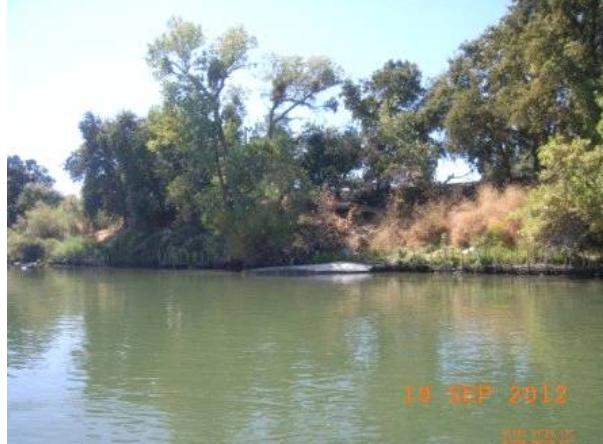
| Waterway | | | | | | | | Bank | Unit Miles | Inspection Start/End | Inspector |
|---|---|---|---|---|---|--|--|---|---|---|---|
| 1 | 0.01 | 0.01 | Supplemental USACE Erosion Survey | WS M | Ma | M | Inspector Comments: 1997 - Structural problem rather than erosional, failed cobble at downstream end. 2005 - New brush boxes at waterline for several hundred feet downstream, No toe or bank protection present. 2006 - Some minor new erosion. Brush boxes not working well; most of the brush has floated out. 2007 - Brush boxes have recently been repaired. 2012: New erosion at the toe. [2012 Site ID: SAC_41-9_R] | 38.417692 ° | 38.414387 ° | 8 | |

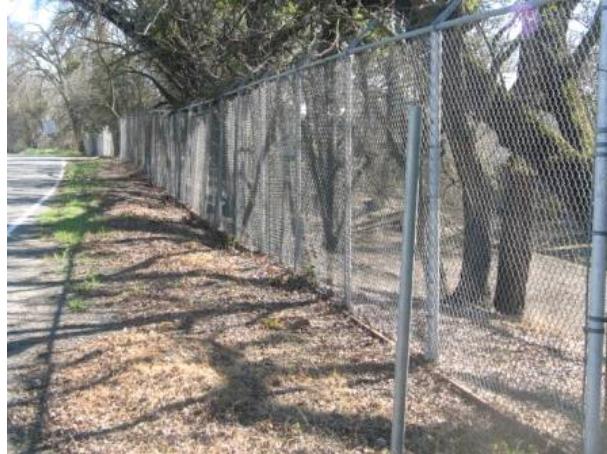
| Cyclone fence along landside shoulder at LM 0.05 -0.11 | richard_f_20130918_344.jpg |

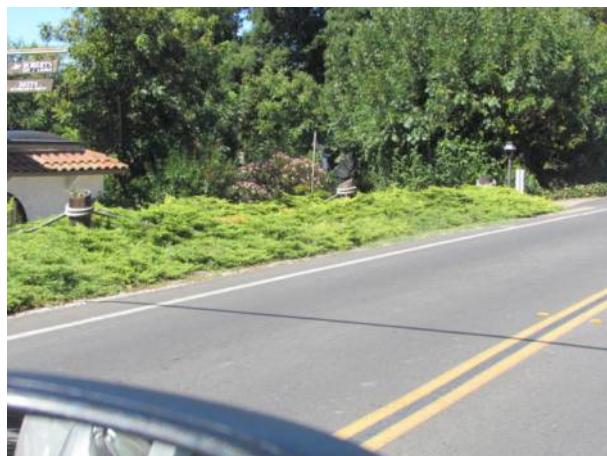
| Looking west at dense landscaping on landward slope. | richard_f_20130930_505.JPG |

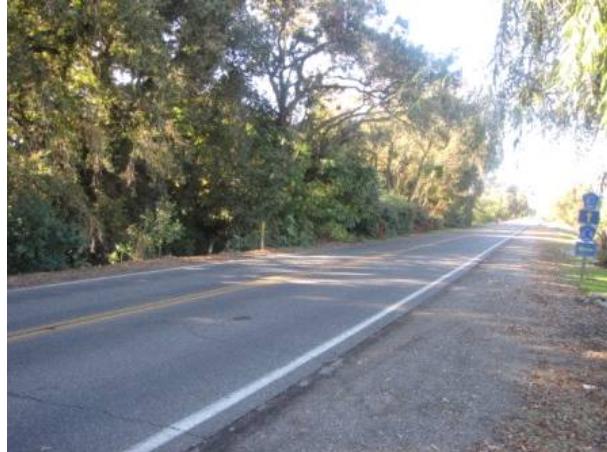
| Looking northwest at dense veg. on landside shoulder and slope. | |

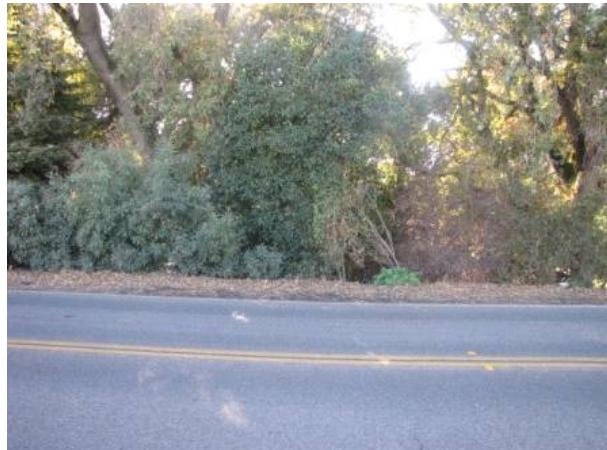
| Looking west at dense veg. on landside slope and toe. | |

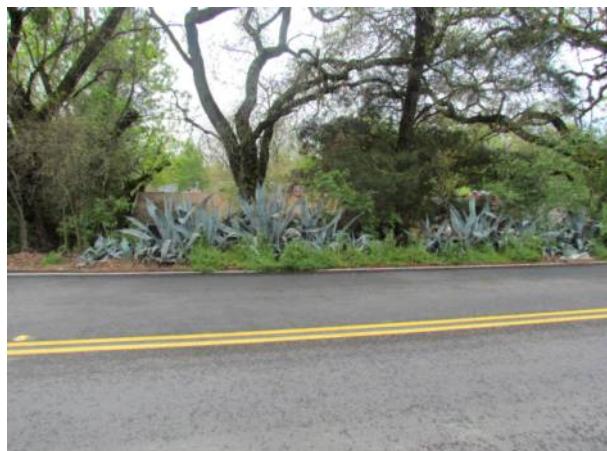
| Looking west at century plants on landside shoulder and slope. | |

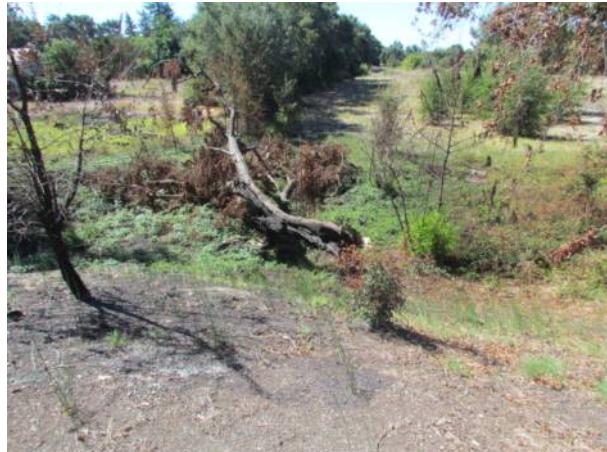
Looking west at dead tree on landward toe and berm.

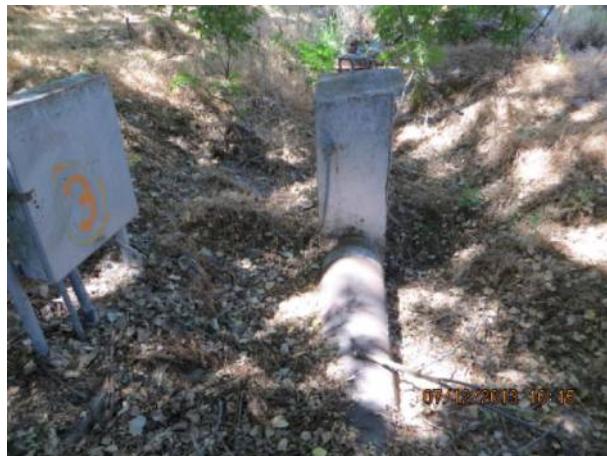
Electrical panel, water meter, and gate valve on LS toe.

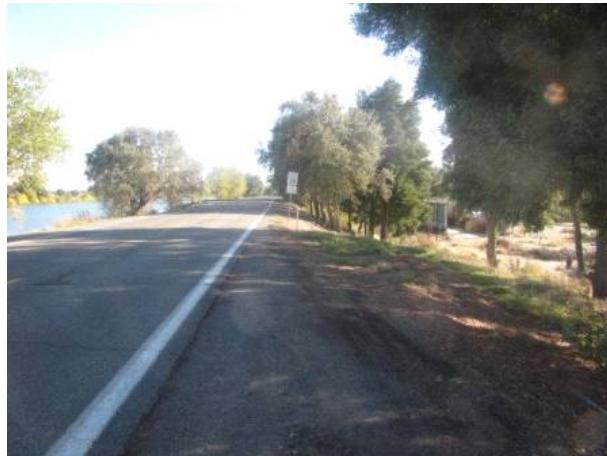
Looking south at trimmed trees on landside slope and removed fence.

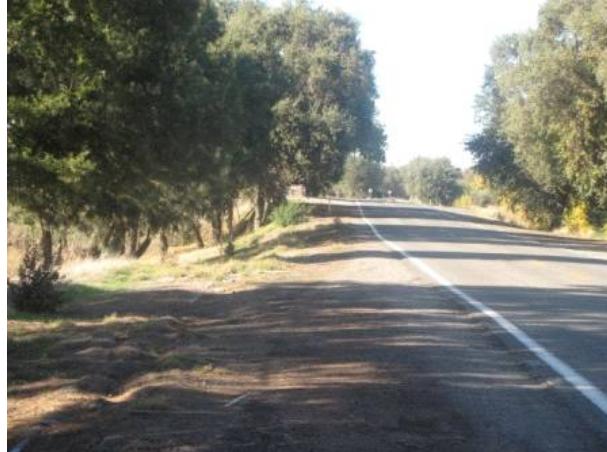
| Looking north at trimmed trees and removed fence on landside slope. | |

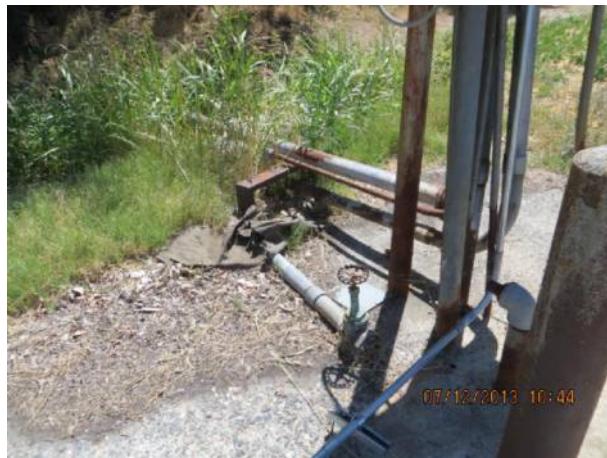
| Pipe with gate valve off LS toe. | |

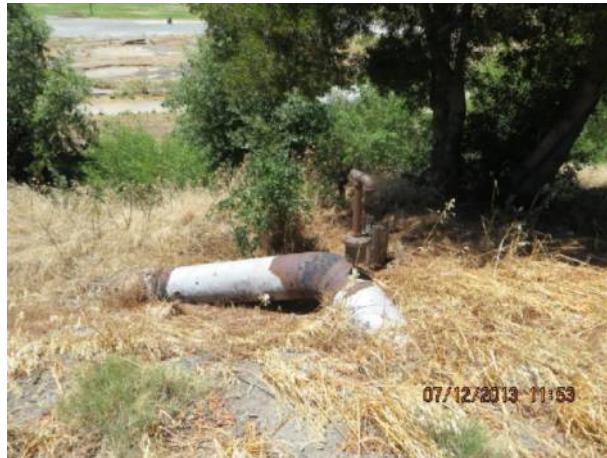
| Pipe and vent/siphon breaker on LS slope. | |

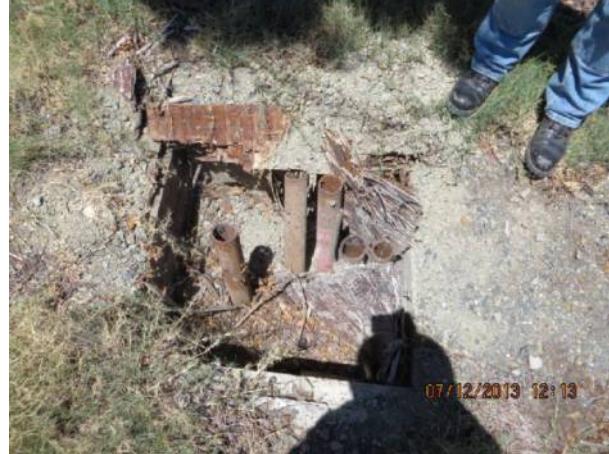
| Pipe in concrete vault on LS shoulder. | |

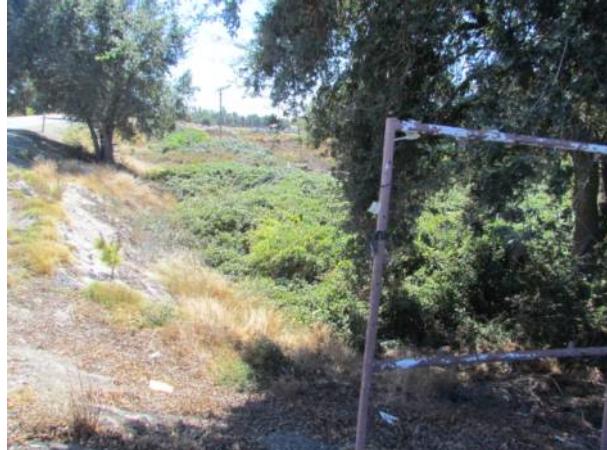
| Looking southwest at dense berry vines at landward toe. 2013 | |

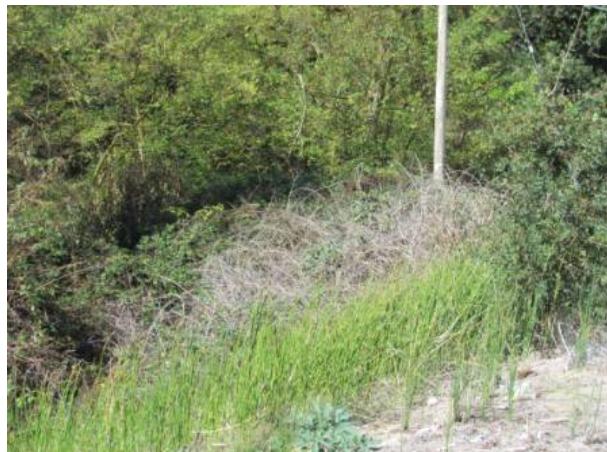
| Looking northwest at dense wild roses and berry vines on landside toe near ramp. | |

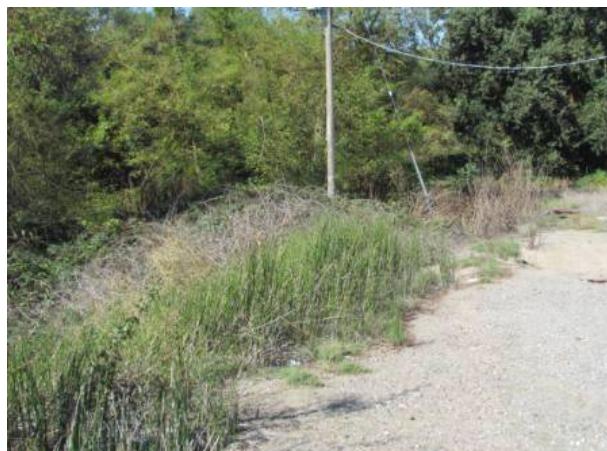
| Looking north at dense vegetation on landside slope near ramp. | |

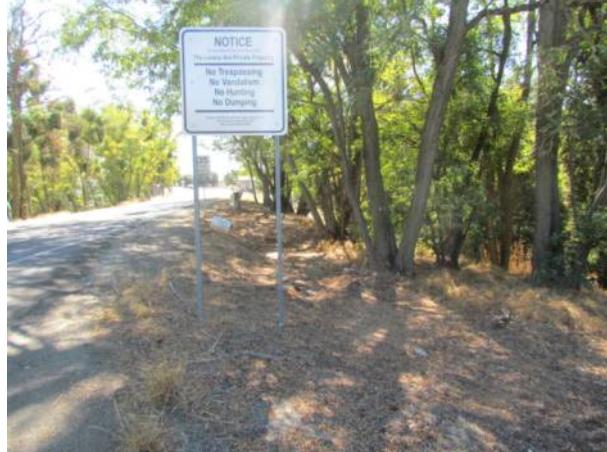
| Looking south at dense trees on landward slope. | |

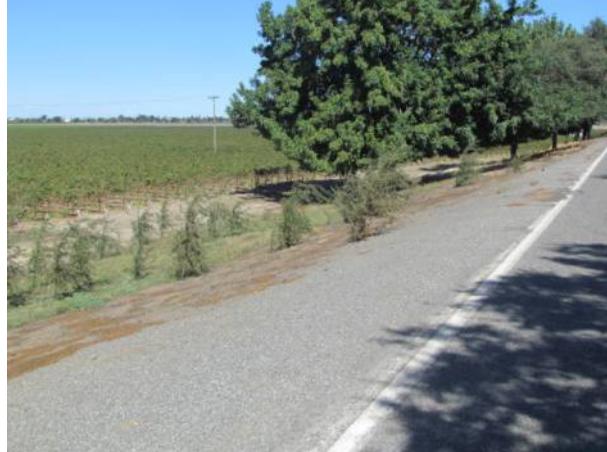
| Looking west at small oak trees on landward slope. | |

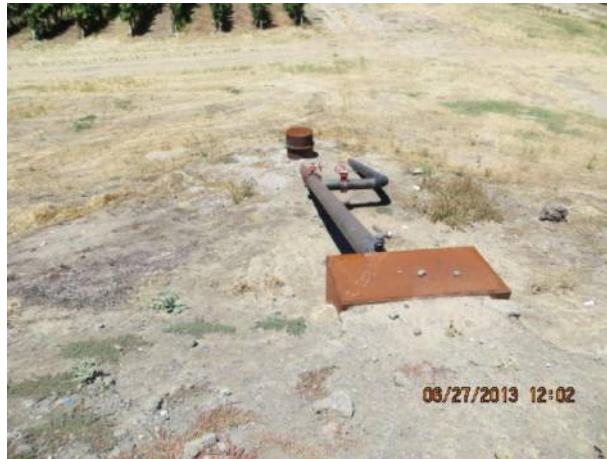
| Steel junction box, vent, butterfly valve, and standpipe visible on LS slope. | |

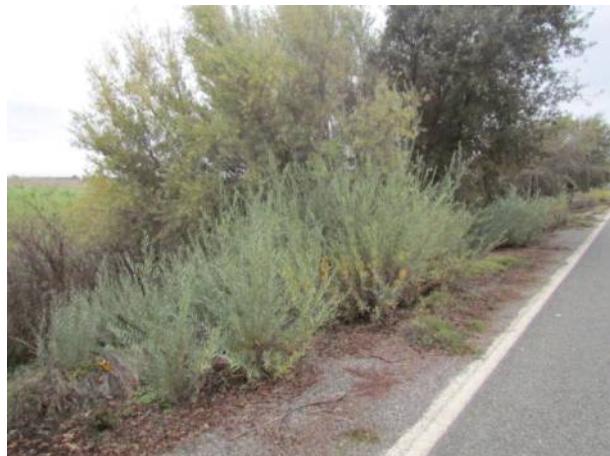
| Looking northwest at vegetation on landside shoulder. (Fall 2012) | |

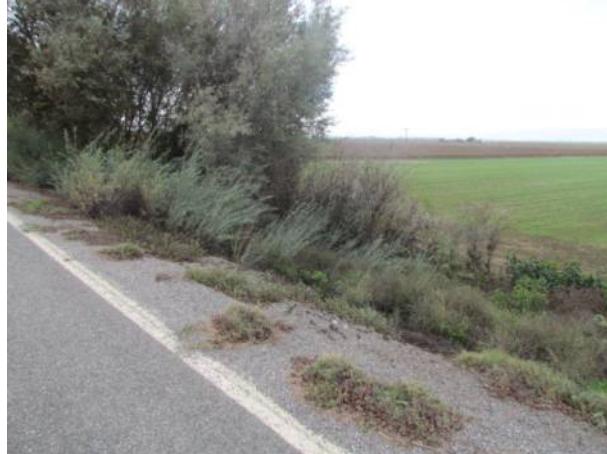
| Looking southwest at vegetation on landside slope and toe. (Fall 2012) | |

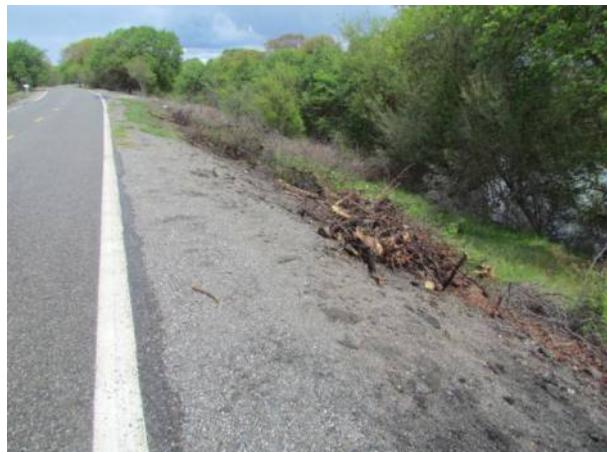
| Looking northeast at prunings on waterside slope. | |

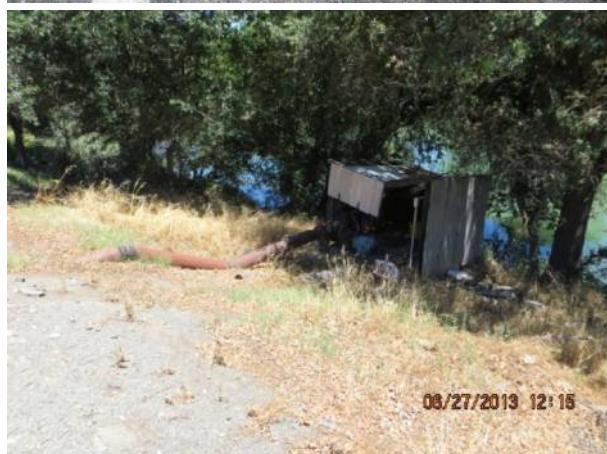
| Pump in pumphouse on WSs llope. | |

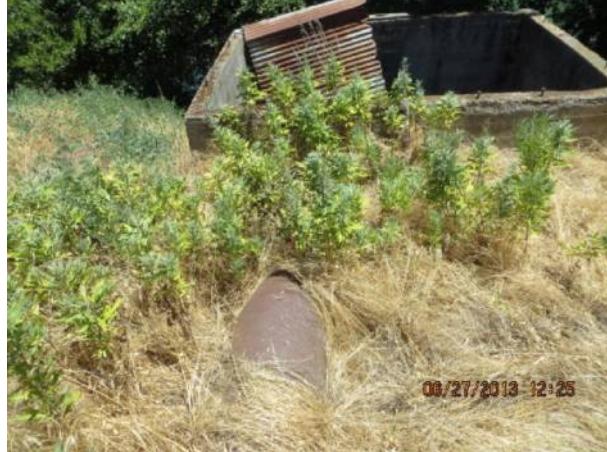
| Pipe visible on WS slope. | |

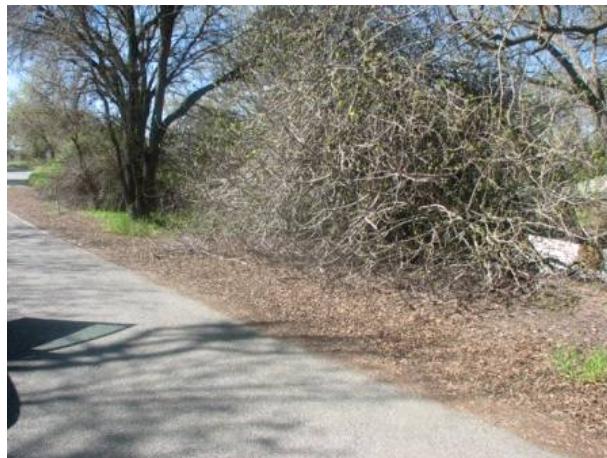
| Front view of dense trees at landside shoulder.(Spring 2011) | |

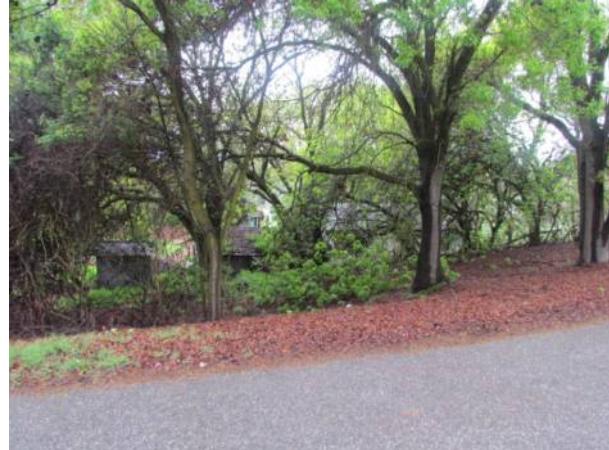
| Looking west at trimmed trees on landside slope.(Spring 2012) | |

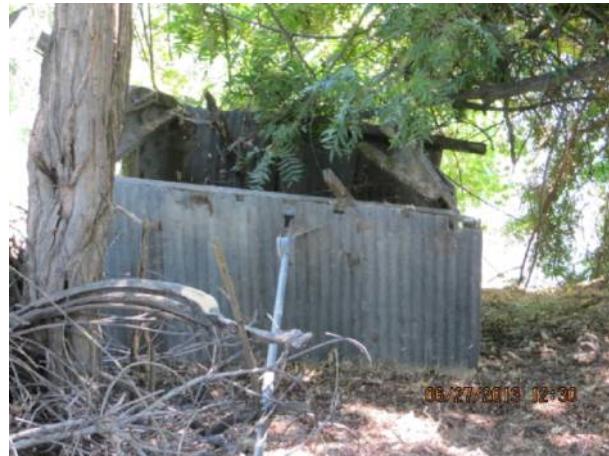
| Pumphouse on WS slope with electrical conduit shown. | |

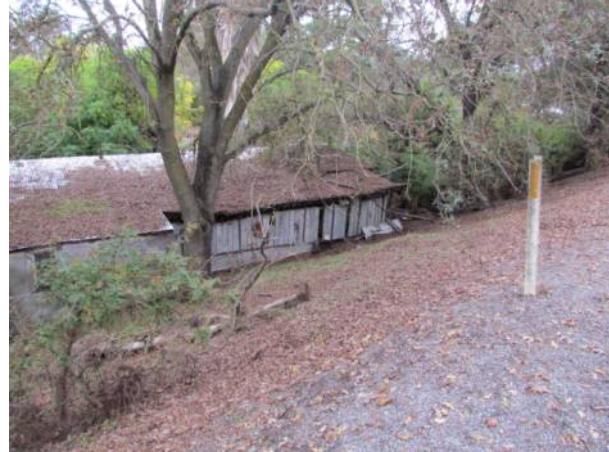
| Looking northwest at storage shed at landside toe and within the 10' easement. | |

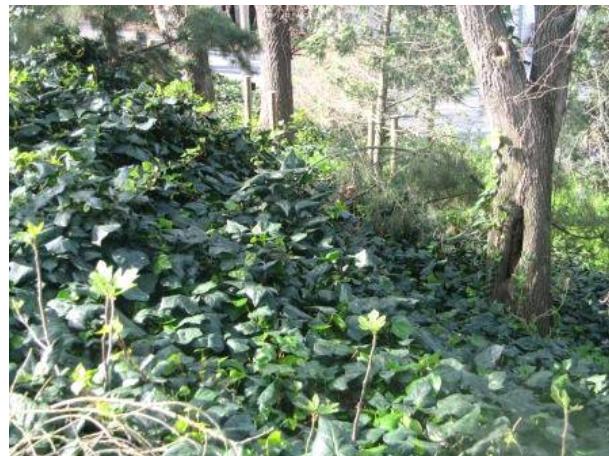
| View of landscaping (Ivy) blocking view of landside slope from LM 0.84 to 0.94 | |

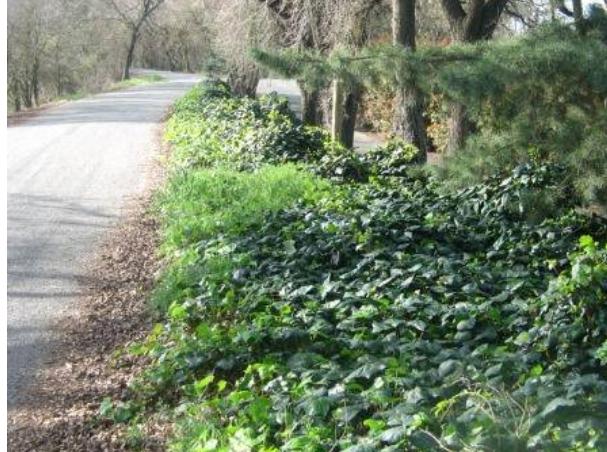
| View of landscaping (Ivy) looking upstream from LM 0.84 to 0.94 | |

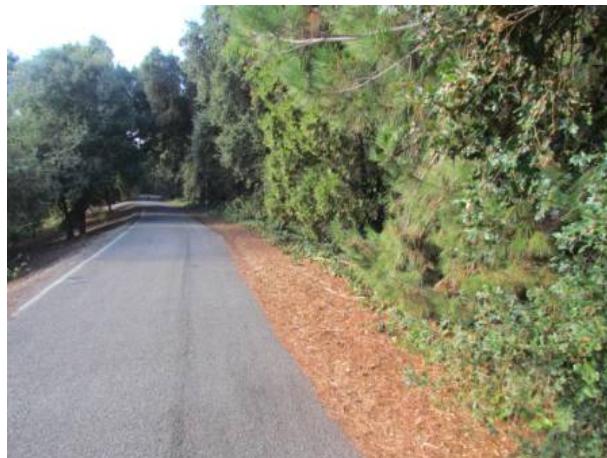
| Looking north at dense landscaping on landside slope. | |

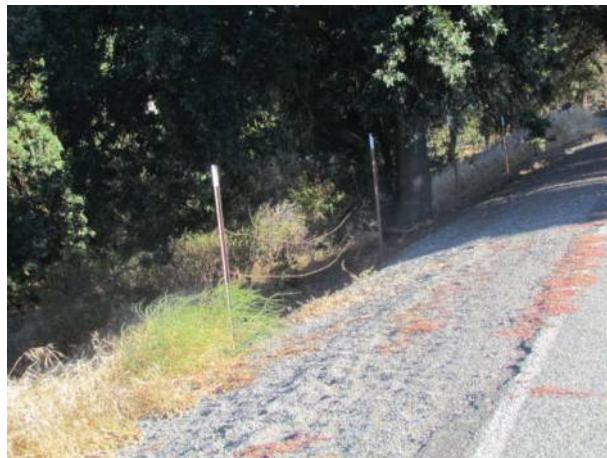
| Looking northwest at fence on landward slope. | |

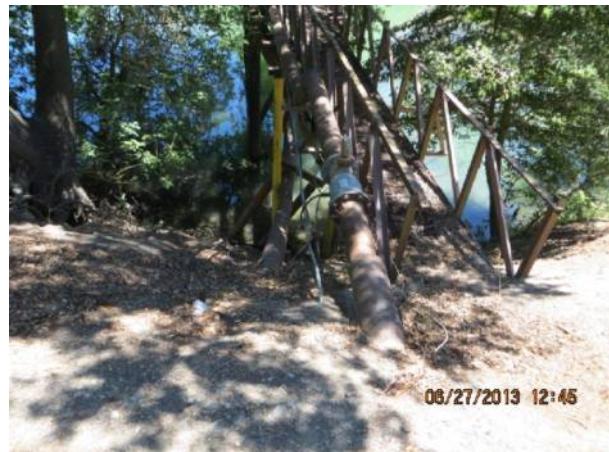
| Pipe visible beneath 10-inch pipe that is currently in use. No connection. | |

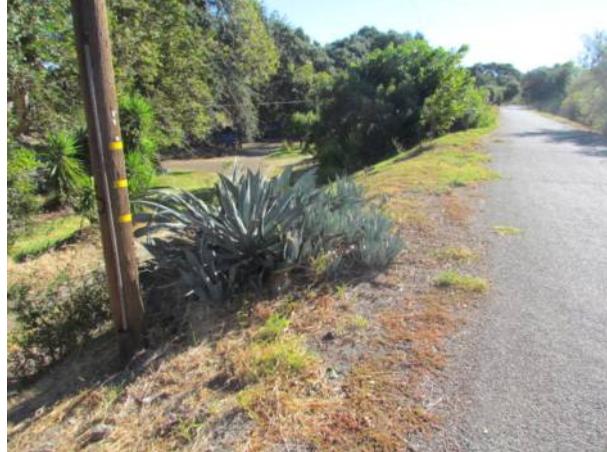
| Looking northwest at landscaping on landward slope. | |

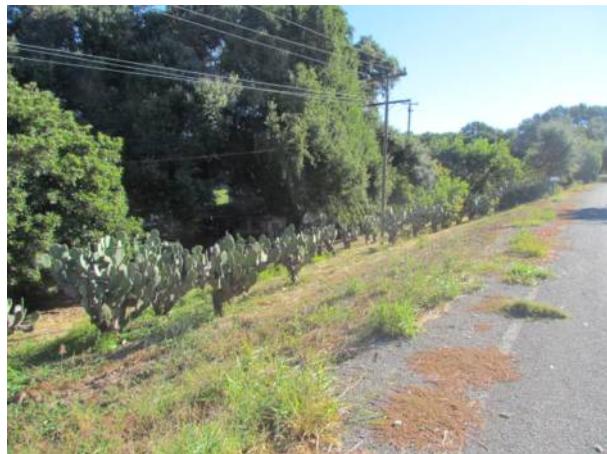
| Looking northwest at several cactus plants on landward slope. | |

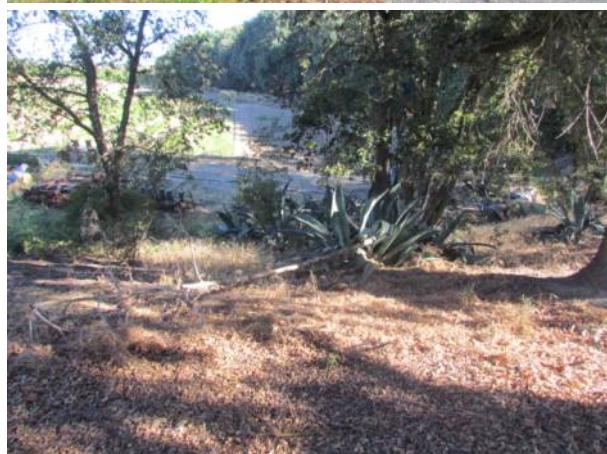
| Looking west at century plants on landward slope. | |

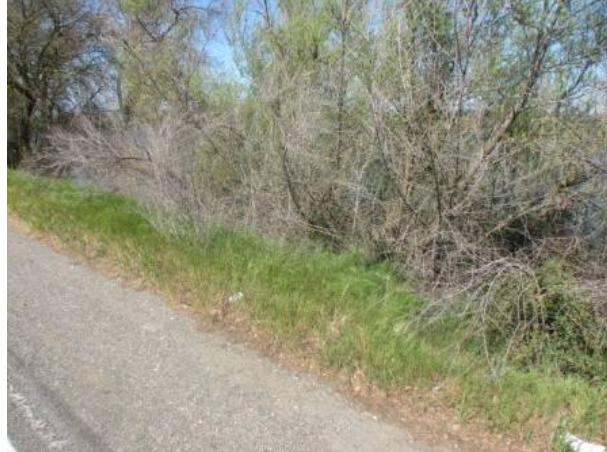
Front view of dense trees along waterside slope.

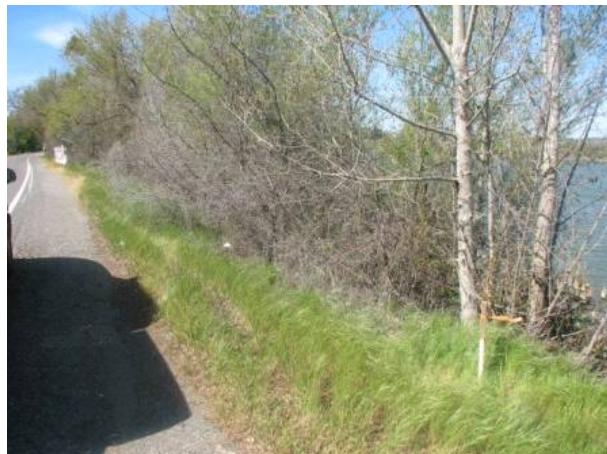
Side view of dense trees along waterside slope.

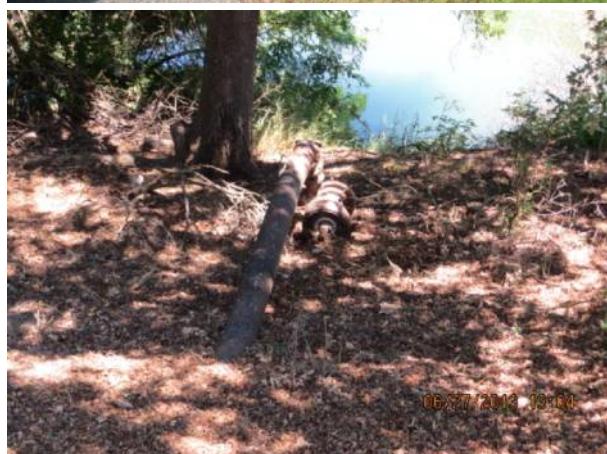
Pipe and pump remnants on WS slope.

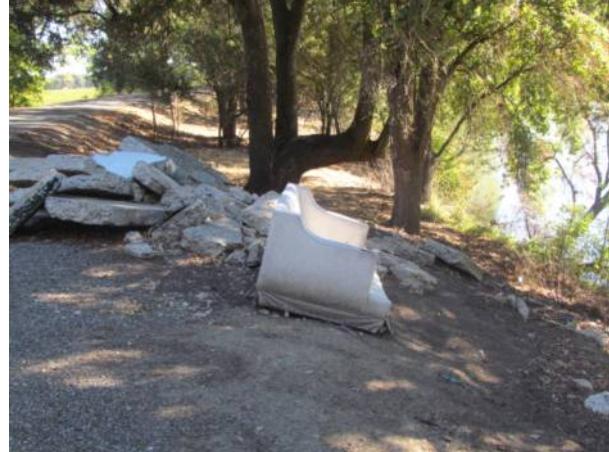
| Looking northeast at garbage (sofa) on waterward slope. | |

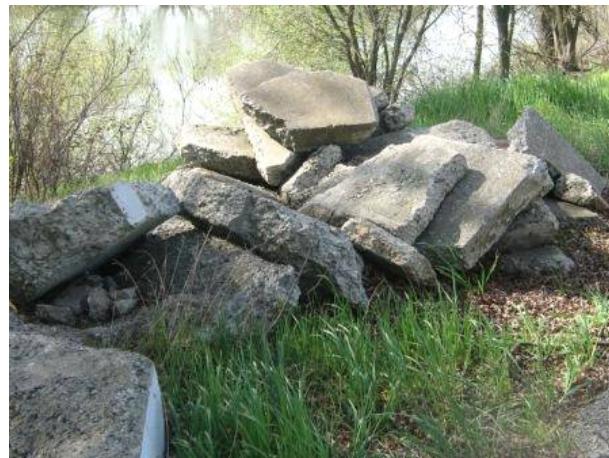
| Concrete rubble on waterside shoulder at LM 1.97 | |

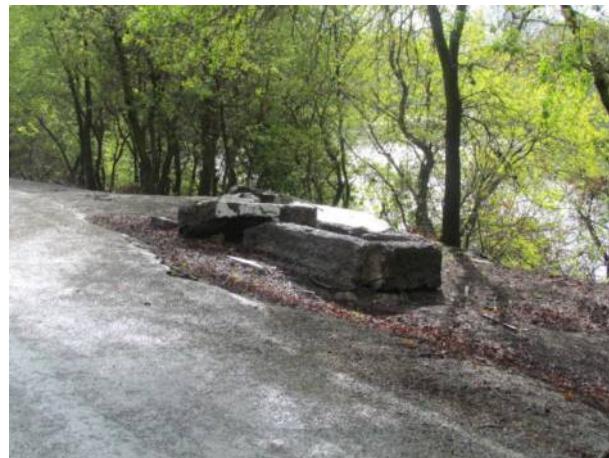
| Looking east at large concrete blocks at the top of ramp on waterside shoulder. | |

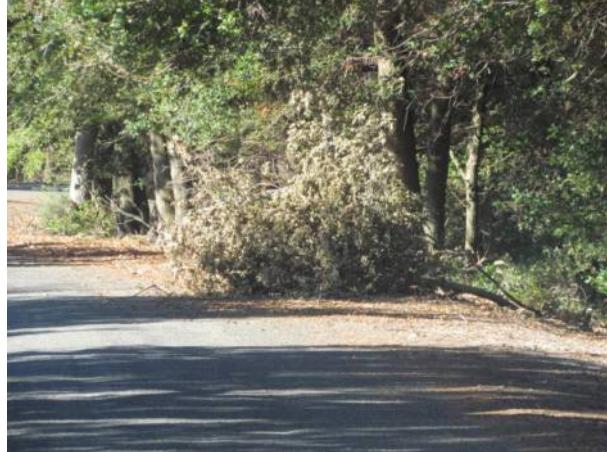
| Looking south at downed tree on landward shoulder and slope. | |

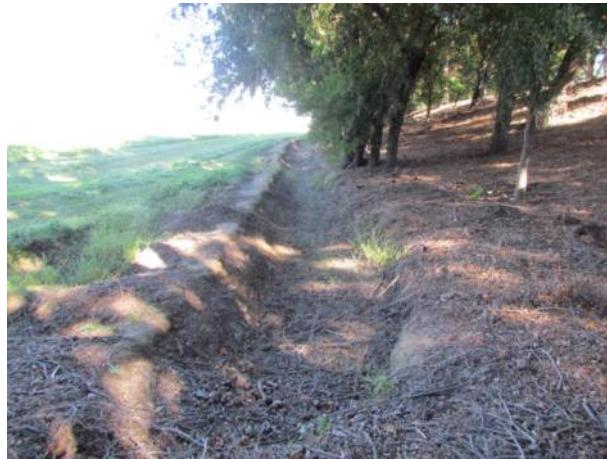
| Looking north at abandoned irrigation ditch at landward toe. | |

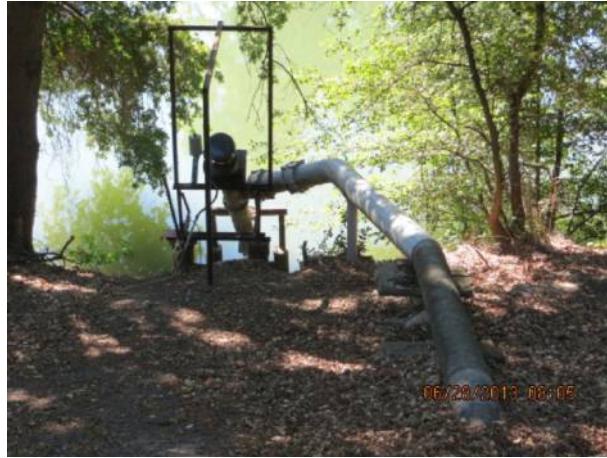
| Slant pump and pipe on WS slope. | |

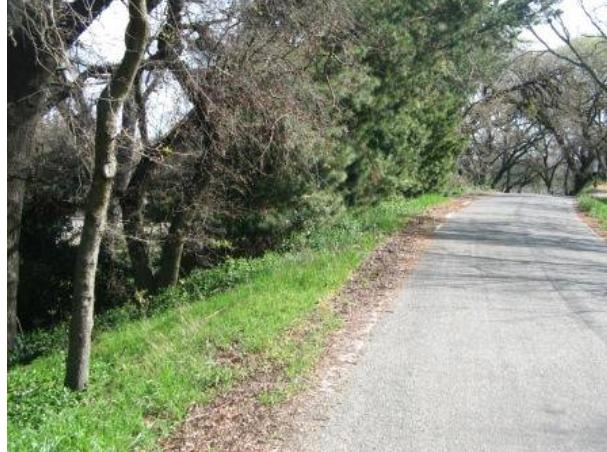
| Looking downstream of landscaping blocking view of landside slope from LM 3.19 to 3.24 | |

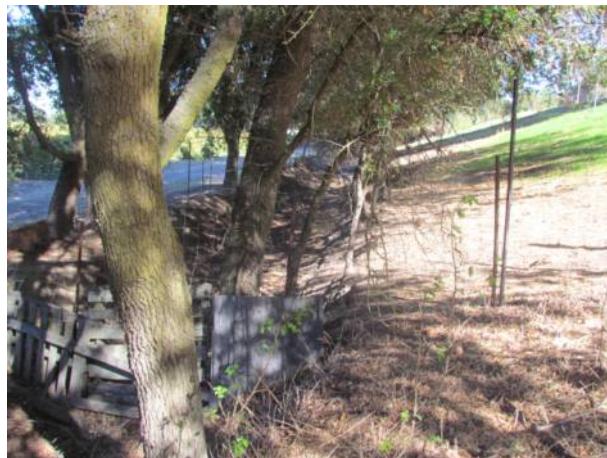
| Looking north at old irrigation ditch at landward toe. | |

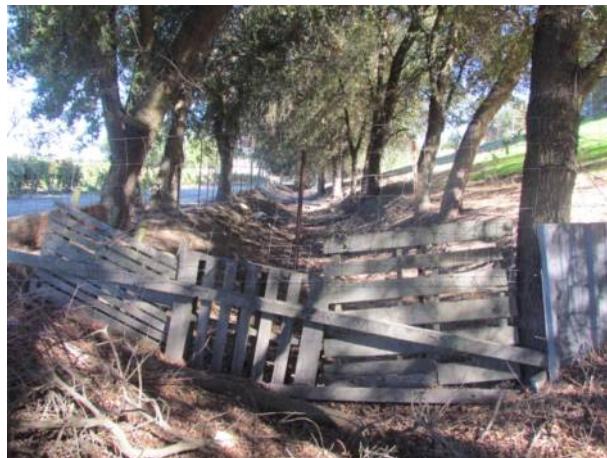
| Looking north at irrigation ditch at landward toe. | |

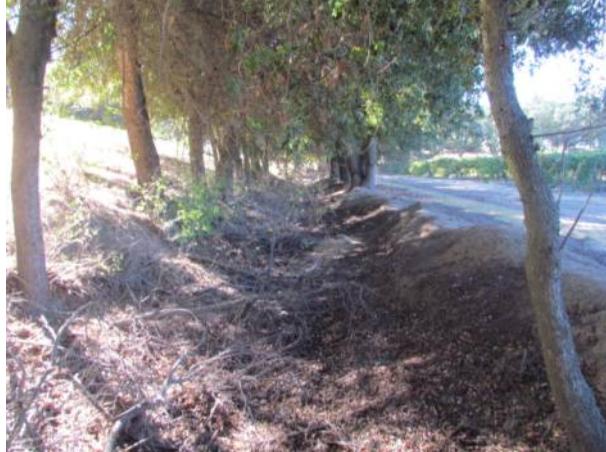
| Looking south at irrigation ditch at landward toe. | |

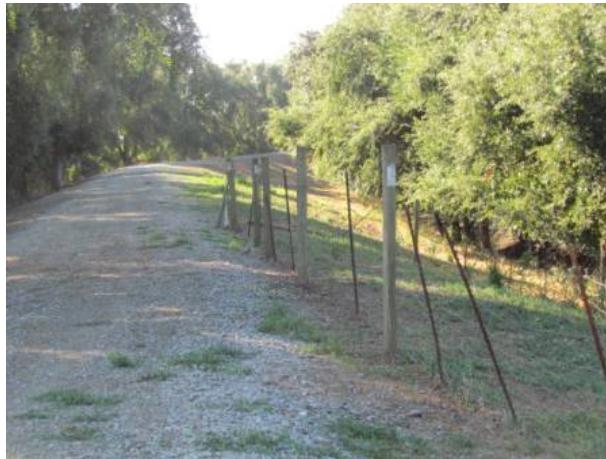
| Looking north at fence along waterside shoulder. | |

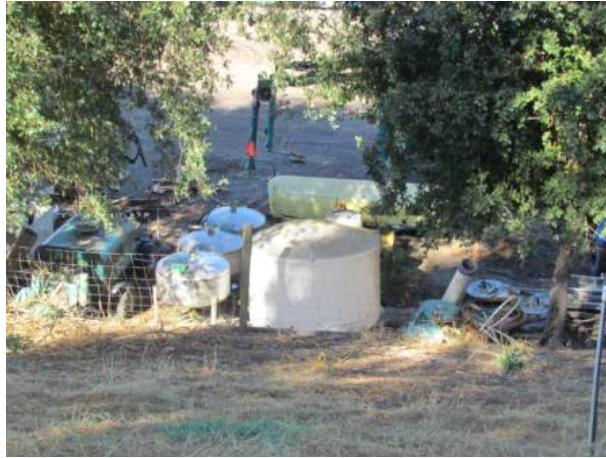
| Looking west at equipment at landside toe. | |

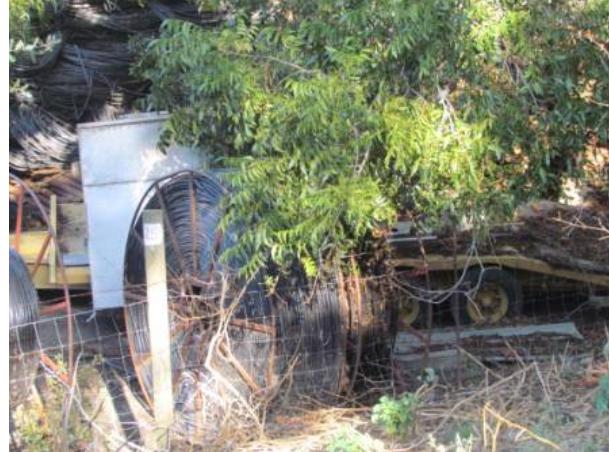
| Looking northwest at equipment on landside toe. | |

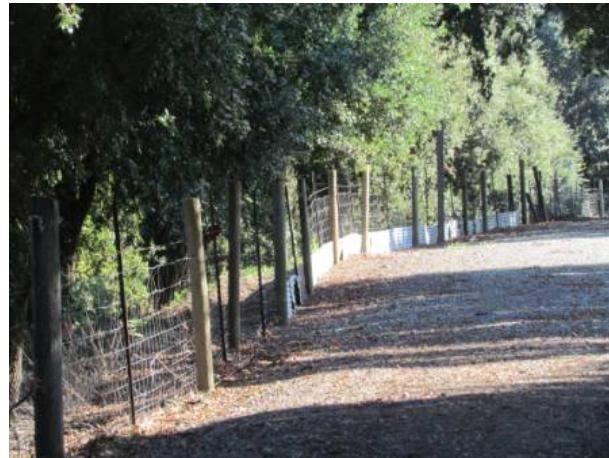
| richard_f_20130918_401.jpg | |

| Looking north at fence along landside shoulder. | |

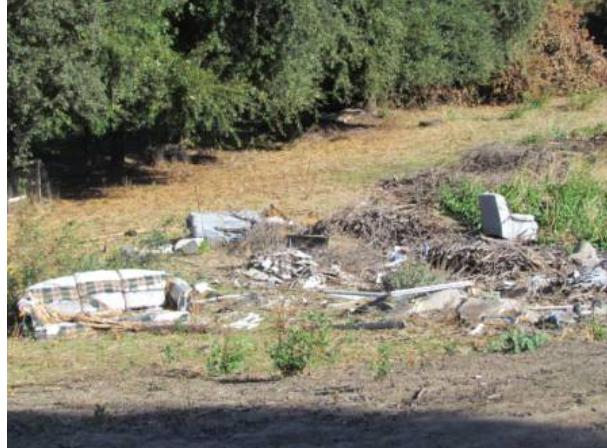
| richard_f_20130918_361.jpg | |

| Looking northwest at garbage on landside toe and berm. (Spring 2011) | |

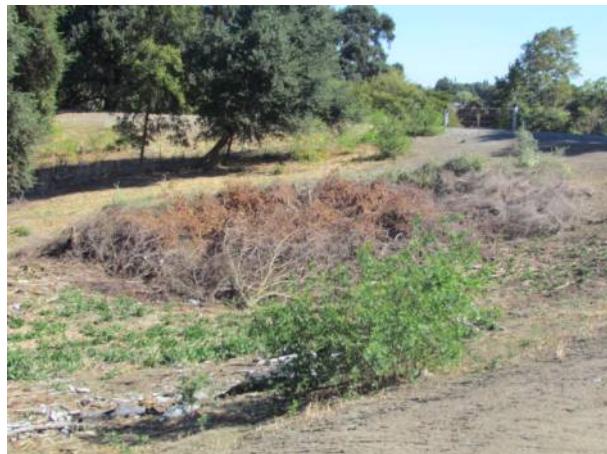
| richard_f_20130927_493.JPG | |

| Looking south at large pruning pile on landward slope. | |

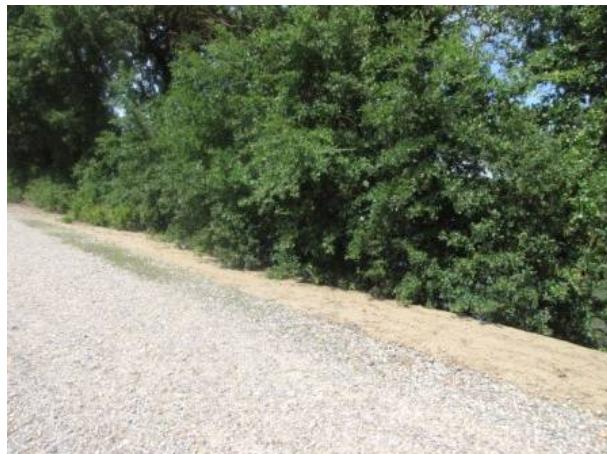
| richard_f_20130918_381.jpg | |

| Looking northeast at overgrown trees on waterside slope.(Spring 2011) | |

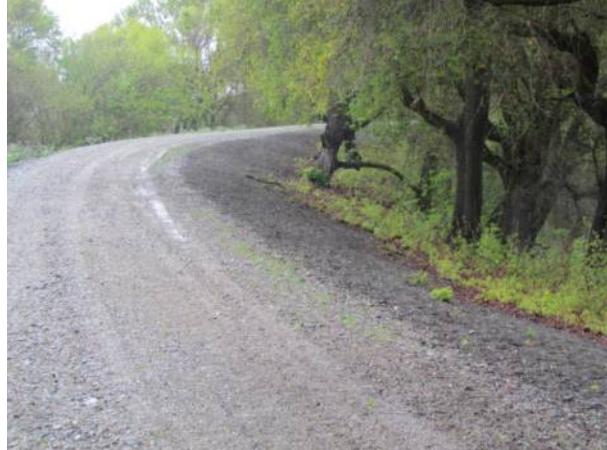
| richard_f_20130918_382.jpg | |

| Looking northeast at trimmed trees on waterside slope. | |

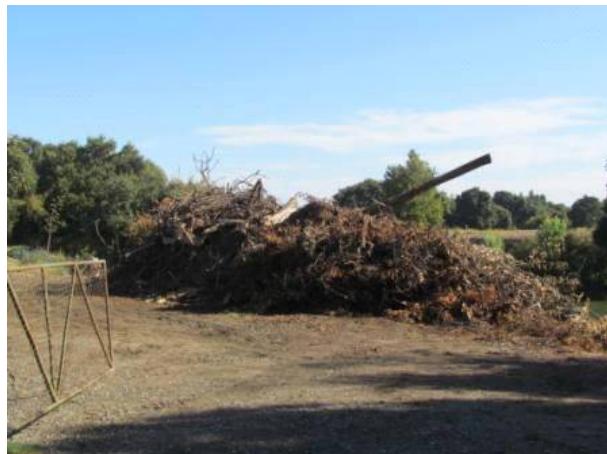
| richard_f_20130918_375.jpg | |

| Looking northeast at larger pruning pile on waterside shoulder. | |

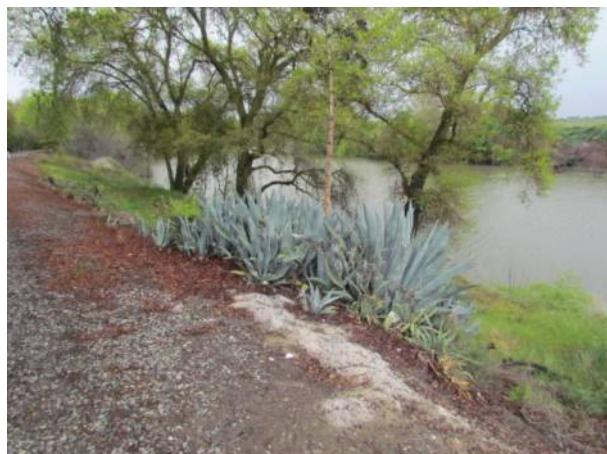
| richard_f_20130918_387.jpg | |

| Looking at century plants on waterside shoulder.(Spring 2012) | |

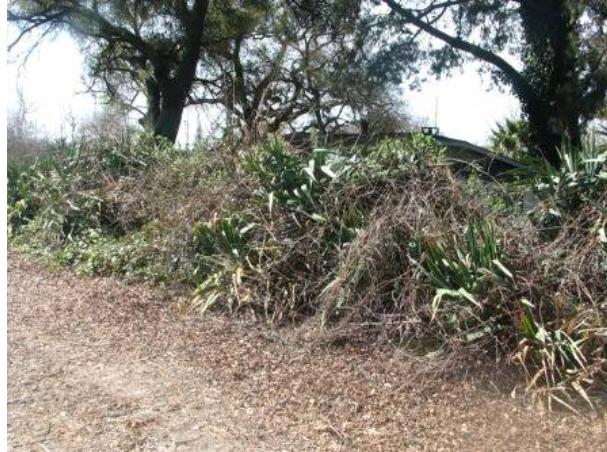
| richard_f_20130918_384.jpg | |

| Overgrown landscaping on landside slope blocking view of slope from LM 4.38 to 4.41 | |

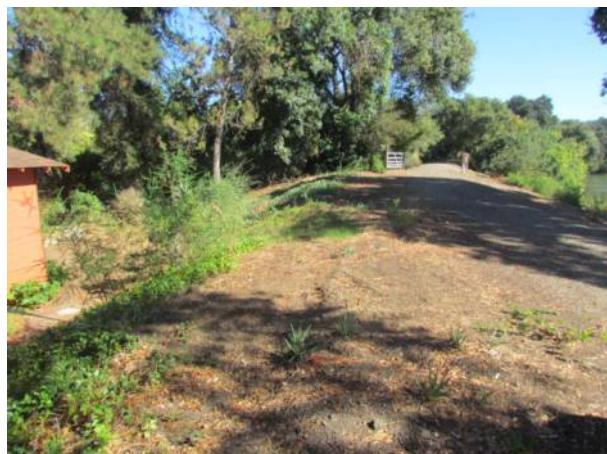
| richard_f_20130927_494.JPG | |

| Looking north at landscaping on landward slope. | |

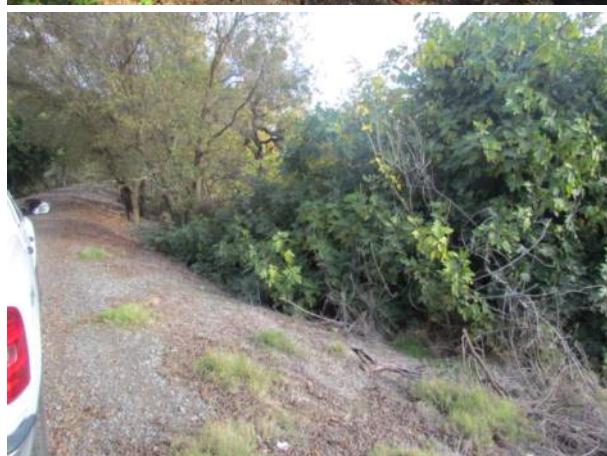
| richard_f_20130918_372.JPG | |

| Looking northeast at fig tree on waterside slope. | |

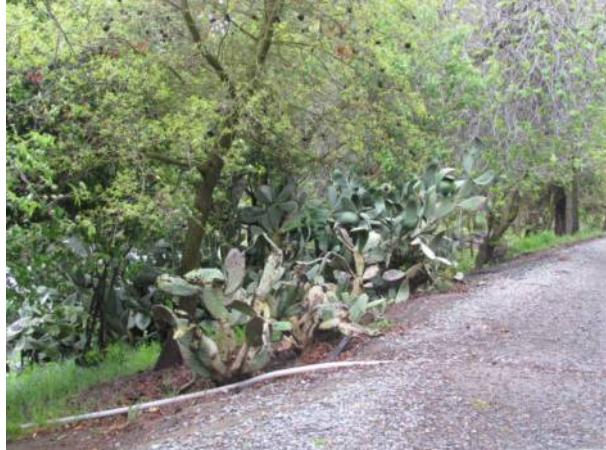
| richard_f_20130918_388.jpg | |

| Looking northwest at cactus on landside shoulder and slope.(Spring 2012) | |

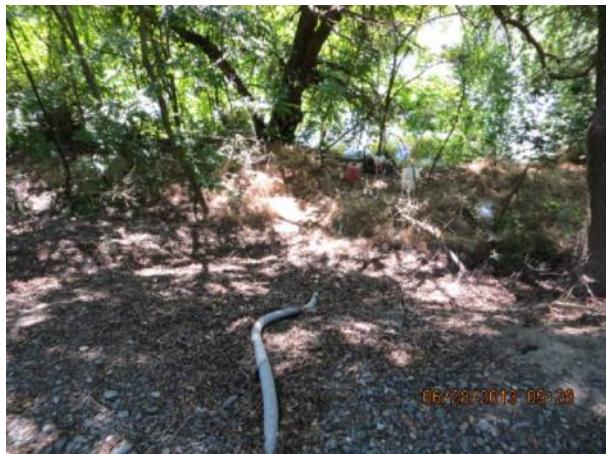
| UCIP_9081.jpg | |

| Flex pipe through the levee 6-inches below the crown with portable pump on WS toe. | |

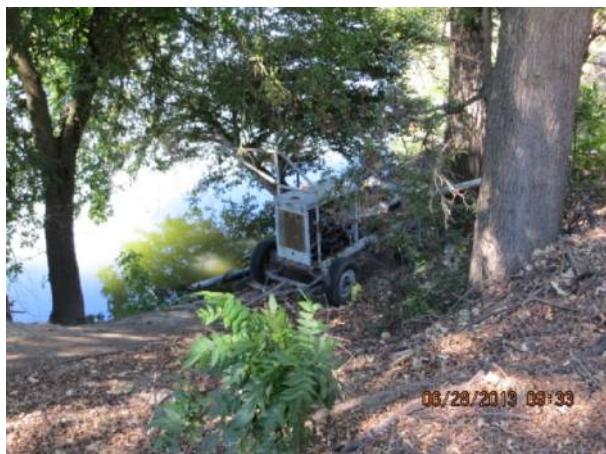
| UCIP_9171.jpg | |

| Portable pump on WS toe. | |

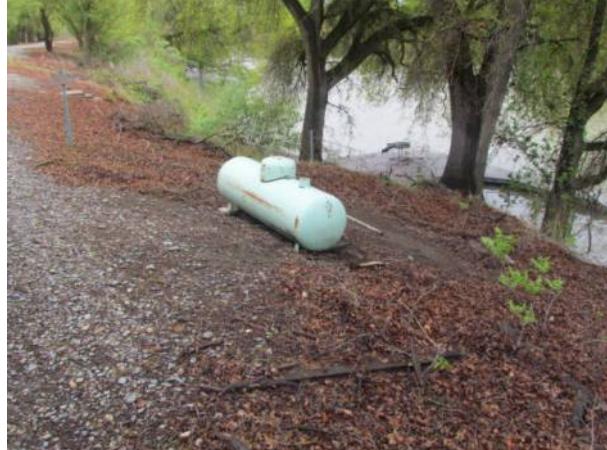
| richard_f_20130918_426.jpg | |

| Looking northeast at propane tank on waterside slope. | |

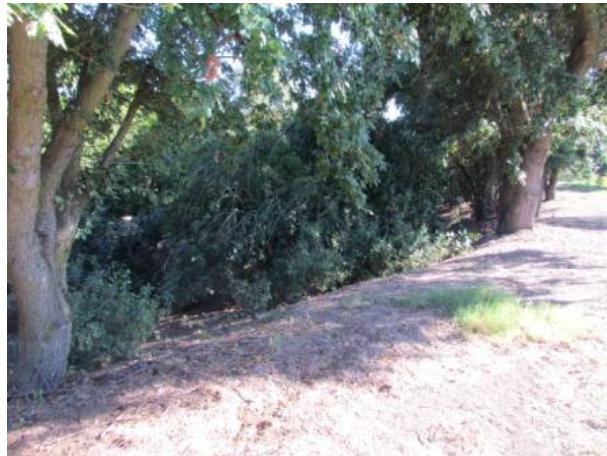
| richard_f_20130918_376.jpg | |

| Looking northwest at dense trees on landside slope.(Spring 2011) | |
